Report No. CG-D-01-99, I

**Investigation of Fuel Oil/Lube Oil Spray Fires
On Board Vessels**

Volume I

**FINAL REPORT
NOVEMBER 1998**

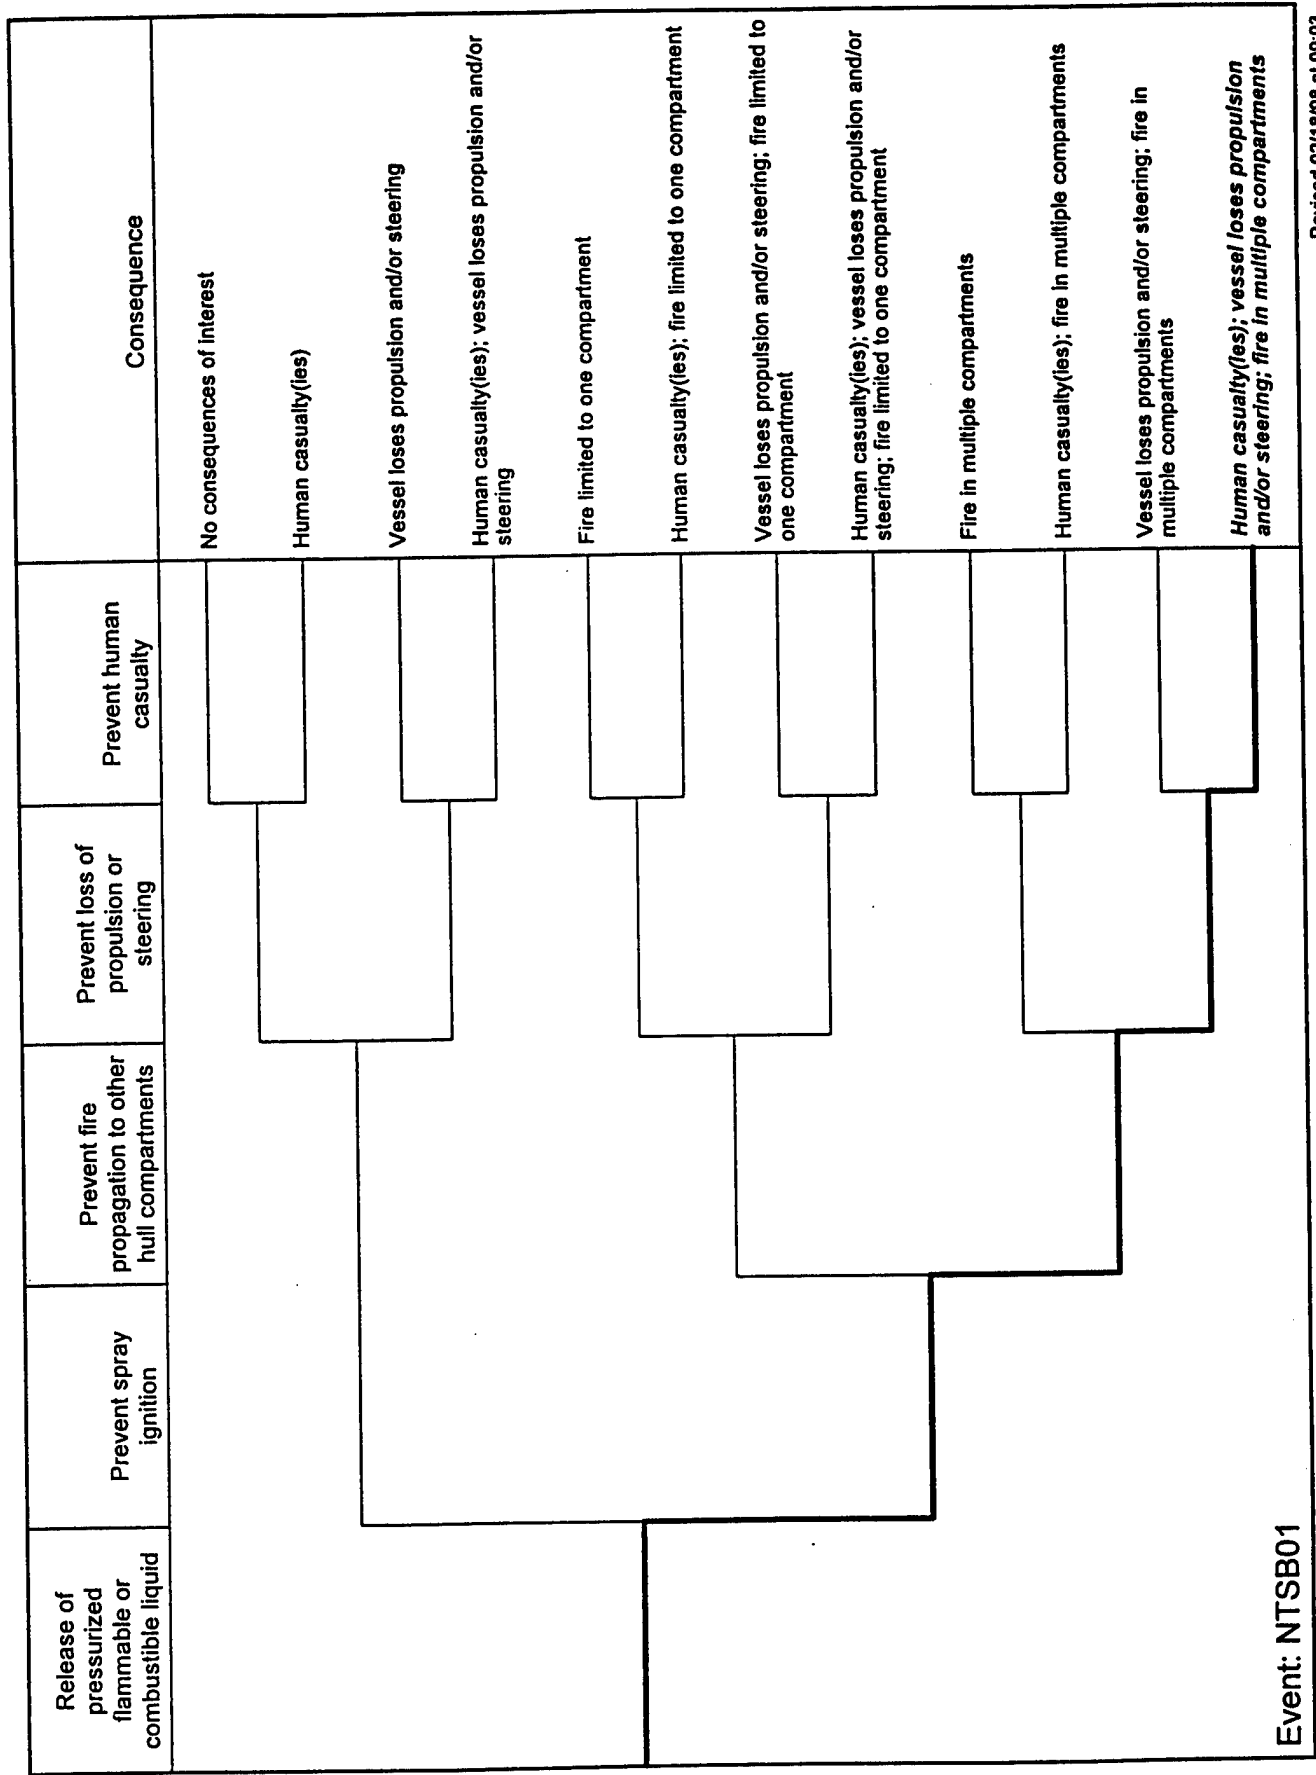
Figure 2.1 Example Event Tree

Event Description (See Appendix G, page G-5)
<p>On June 10, 1994, the lubricating oil duplex strainer on the SEAL ISLAND's turbogenerator had a defective O-ring (gasket) that was leaking about 6 gallons of oil daily. To avoid shutting down the ship's service turbogenerator for 2 hours to make a permanent repair to the duplex strainer, the chief engineer devised an assembly comprising an O-ring, a metal cup, and a screw-jack. The cup was to fit around the bottom of the flow valve casing. The screw-jack was to hold the cup in place to achieve and maintain a tight fit. When the first engineer tried to attach the O-ring and cup, the valve's lower securing pin prevented his getting a tight seal. The chief engineer directed him to retract the lower securing pin ... the replacement chief engineer cautioned that it was dangerous to remove the pin without having a device to hold the flow valve in place. The chief engineer designed a strongback, which was fabricated by a machinist in about 10 hours. On June 12, all four components of the temporary assembly were fitted on the oil strainer and the oil leak stopped.</p>

<p>On October 8, 1994, the Liberian tankship SEAL ISLAND was moored at the Hess Oil Refinery in St. Croix, U.S. Virgin Islands. About 0845, while engineering personnel were changing the lubricating oil strainer on the ship's service turbogenerator, lubricating oil sprayed onto the hot turbine casing and a fire erupted. The fire burned about 6 hours before it was extinguished.</p>
<p>The fire resulted in the death of three crew members and serious injury of six other crew members. The fire seriously damaged the tankship's engine room; heat, smoke, water, and soot badly damaged the accommodations and pilothouse. The tankship was declared "no longer a useful carrier" and its owner, the Seal Island Shipping Corporation, had it towed to Spain where it was sold as scrap for \$12 million.</p>
<p>The National Transportation Safety Board determines that the probable cause of the fire on board the SEAL ISLAND was the chief engineer's failure to recognize the risks introduced by the temporary repair to the engine room oil strainer. Contributing to the loss of life were the suddenness and severity of the fire, the inability of the crew to use the control room emergency escape hatch, and the lack of fire and escape drills in the vessel engine room.</p>

Figure 2.1 shows the event tree for this incident. The event tree provides a general overview of what happened during the incident and the resulting consequences. It starts with an initiating event (release of fuel oil or lube oil [generically represented by "pressurized flammable or combustible liquid"]), and then proceeds to indicate whether important functions (prevent spray ignition, prevent fire propagation to other compartments, prevent loss of propulsion or steering, and prevent human casualty) were successful or unsuccessful. Each of these functions is represented by a "branch point" in the event tree. By definition, we indicate a success for a function by moving up at the branch point for the function and a failure by moving down at the branch point for the function.

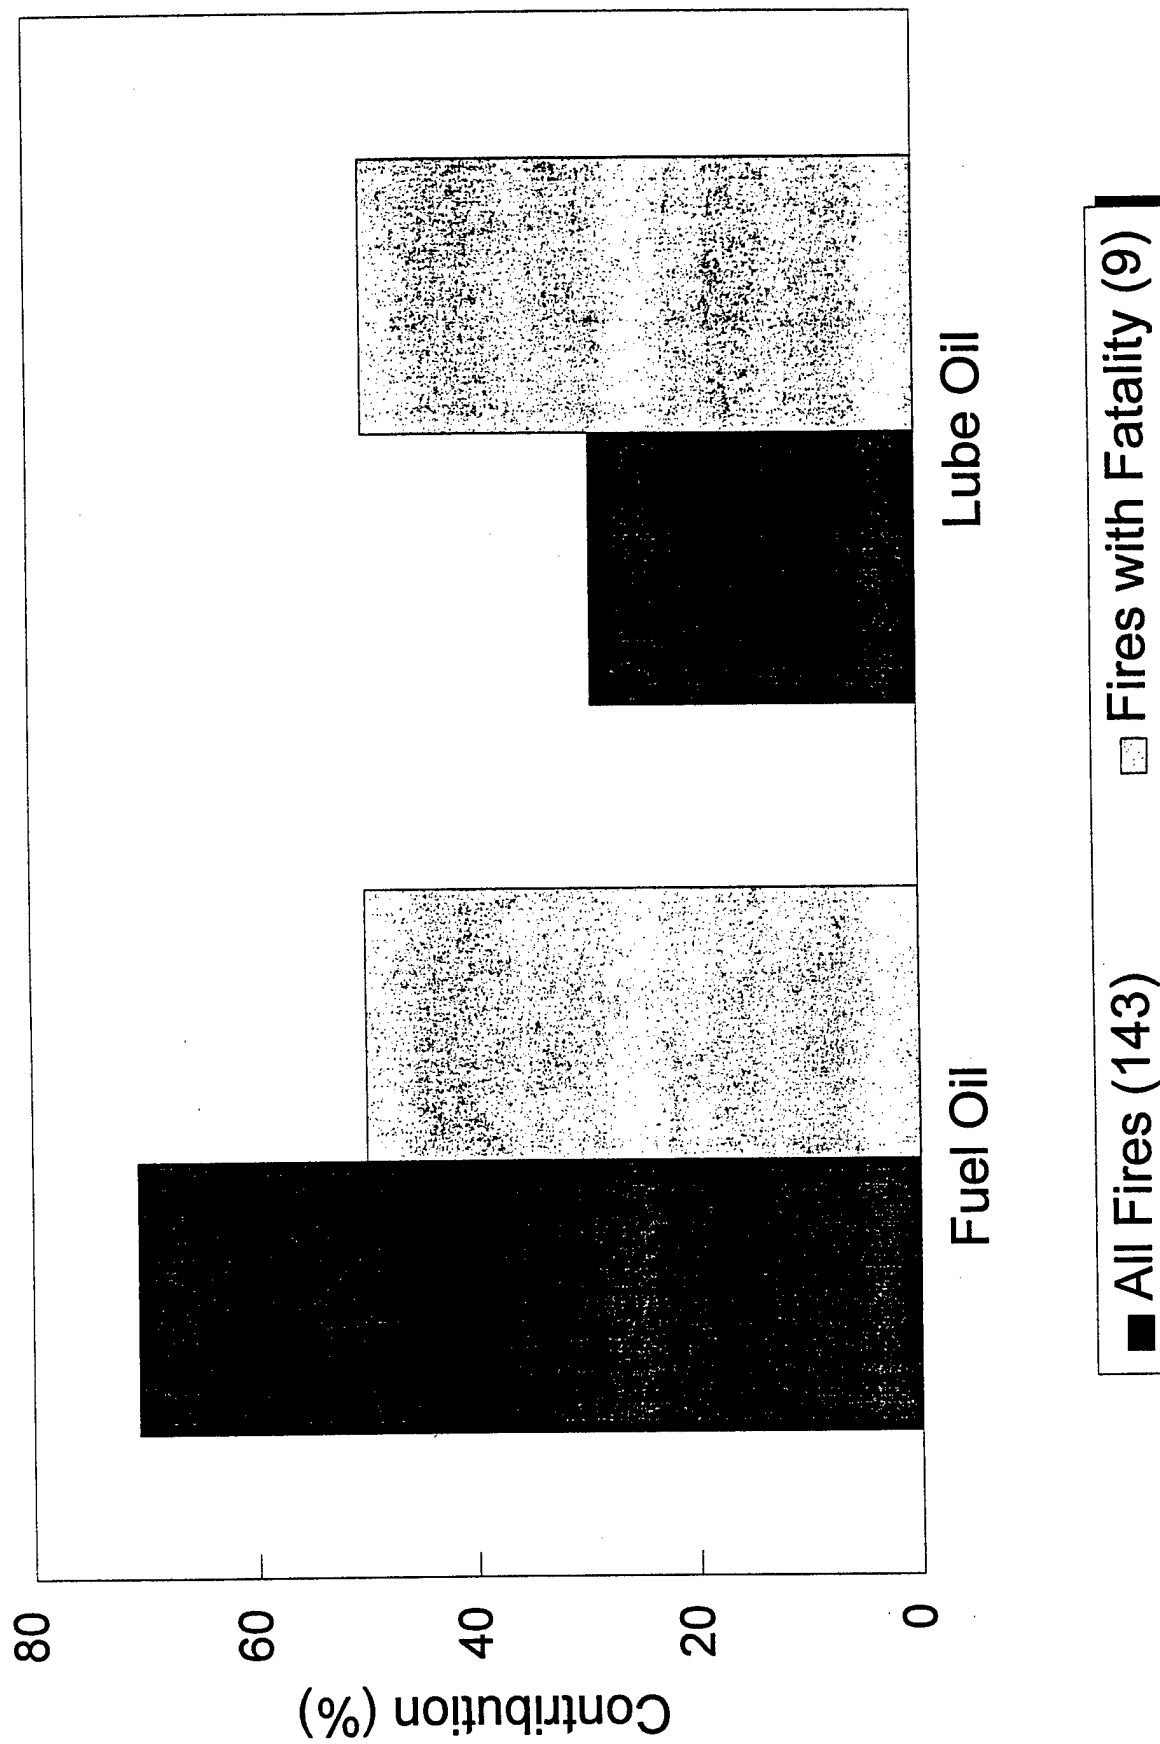
Figure 3.11 System Involved in the Fire

3.4 System Involved in Fires Caused by the Release of Fuel Oil/Lube Oil — Figure 3.11 shows that fuel oil systems account for about 70% of all oil fires while lube oil systems account for about 30%. However, when fires with fatality are considered, these contributions are 50% for fuel oil systems and 50% for lube oil systems. This indicates that while fuel oil fires occur more often (about twice as much) than lube oil fires, the fewer lube oil fires have caused as many fatal incidents as fuel oil. Figure 3.12 further illustrates this point. The probability of a fatality given a fuel oil fire is about 4% while the probability of a fatality given a lube oil fire is about 10% (more than twice as much). *Therefore, lube oil fires are less frequent than fuel oil fires, but they tend to be more fatal when they do occur.*

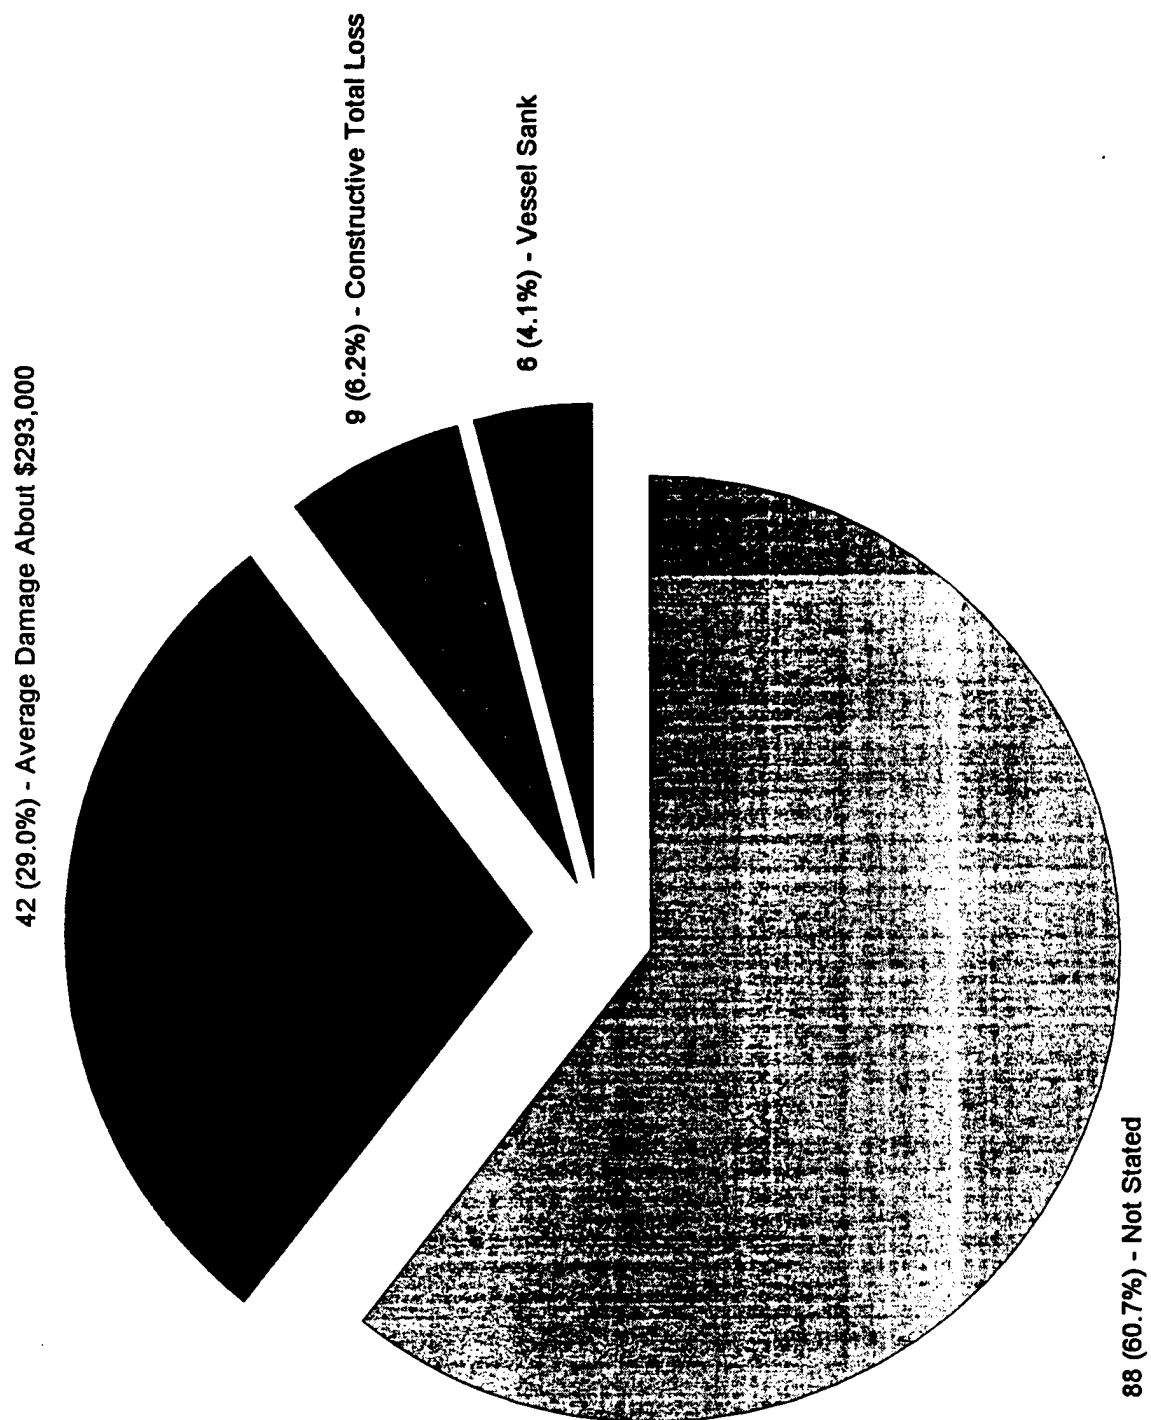
Figure 3.13 Damage Characterization

3.5 Damage Characterization — Figure 3.13 shows that the damage incurred in many spray fires (about 61%) was not stated in the incident reports. However, damage information was available in 57 incident reports, and Figure 3.13 shows that it is extensive.^h The vessel sank in 6 of the incidents, incurred constructive total loss in 9 of the incidents, and incurred an average of about \$293,000 in the remaining 42 incidents.

^hIn addition to the 55 incident reports in Appendixes A through G that provided damage information, Figure 3.13 considers the damage from two other incidents: *Fire on Board the Bahamian Passenger Ship THE SCANDINAVIAN STAR in the Gulf of Mexico, March 15, 1988*, NTSB/MAR-89/04, National Transportation Safety Board, Washington, DC, July 1989, and *Engineroom Fire Aboard the U.S. Tankship CHARLESTON in the Atlantic Ocean About 35 Miles off the South Carolina Coast, March 7, 1989*, NTSB/MAR-90/06, National Transportation Safety Board, Washington, DC, October 1990. These two incidents were not included in the appendixes because these reports became available after the hazard evaluation described in Step 7 in Section 2. We considered them in Figure 3.13 because they were among the most expensive engine room fires for the shipping industry.

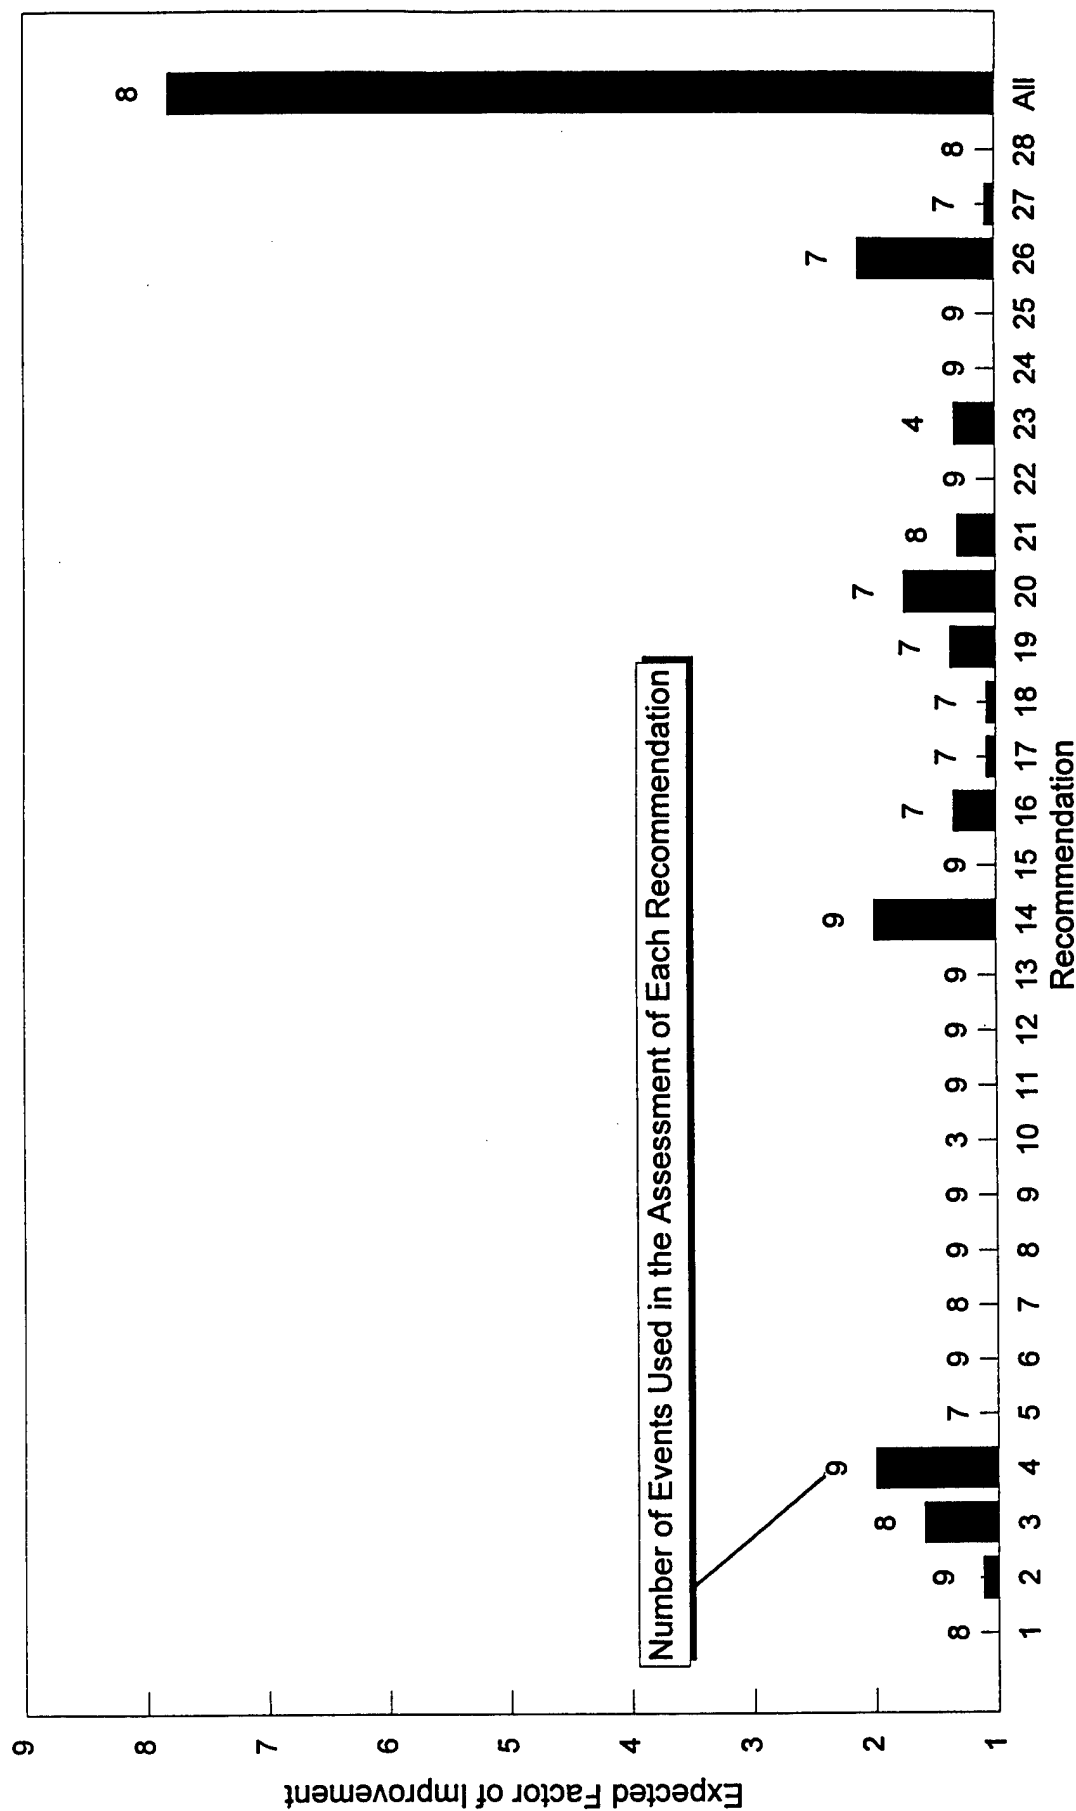
Figure 3.17 Expected Factors of Improvement for Preliminary Recommendations
(All Fires with Fatality)

Figure 3.17 shows similar results for the impact of preliminary recommendations on fires with fatality. In this case, the individual impact of some of the preliminary recommendations (i.e., 4, 14, and 26) is about 50% reduction in the frequency of fatal fires (factor of 2 improvement). Also, the combined impact of all preliminary recommendations is a factor of about 8 improvement (reduction of the frequency of incidents to 13% of its frequency without the benefits of these recommendations), primarily because of preliminary recommendations 3, 4, 14, 16, 19, 20, 21, 23, and 26.
